# Uniform Mitigation Verification Inspection Form

Inspection Date: October 12, 2013		
<b>Owner Information</b>		
Owner Name: Bordeaux Village Association No. 2, Inc.		Contact Person:
Address: 2473 Kingfisher Ln. (Bldg I - Units 101, 102, 103, 202 & 203)		Home Phone:
City: Clearwater	Zip: 33762	Work Phone:
County: Pinellas		Cell Phone:
Insurance Company:		Policy #:
Year of Home: 1980	# of Stories: 2	Email:

**BORDEAUX VILLAGE ASSOCIATION NO. 2, INC.  
2473 KINGFISHER LANE (BLDG. D)  
CLEARWATER, FL 33762**

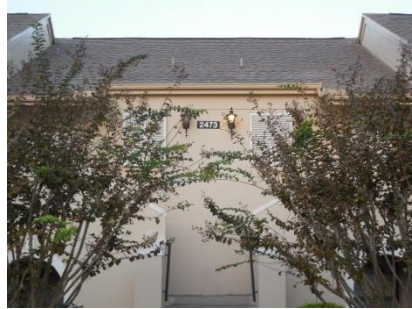
**Roof**

2.1 Roof Covering Type:	Permit Application Date	FBC or MDC Product Approval #	Year of Original Installation or Replacement	No Information Provided for Compliance
<input checked="" type="checkbox"/> 1. Asphalt/Fiberglass Shingle	___/___/___	_____	2013	<input type="checkbox"/>
<input type="checkbox"/> 2. Concrete/Clay Tile	___/___/___	_____	_____	<input type="checkbox"/>
<input type="checkbox"/> 3. Metal	___/___/___	_____	_____	<input type="checkbox"/>
<input type="checkbox"/> 4. Built Up	___/___/___	_____	_____	<input type="checkbox"/>
<input type="checkbox"/> 5. Membrane	___/___/___	_____	_____	<input type="checkbox"/>
<input type="checkbox"/> 6. Other _____	___/___/___	_____	_____	<input type="checkbox"/>

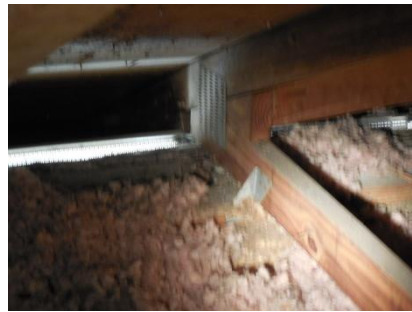
**Clips**

- B. Clips
  - Metal connectors that do not wrap over the top of the truss/rafter, or
  - Metal connectors with a minimum of 1 strap that wraps over the top of the truss/rafter and does not meet the nail position requirements of C or D, but is secured with a minimum of 3 nails.
